# Status of NHTSA's Ejection Mitigation Research

J. Stephen Duffy  
Transportation Research Center, Inc.

SAE Government/Industry Meeting  
May 9, 2005

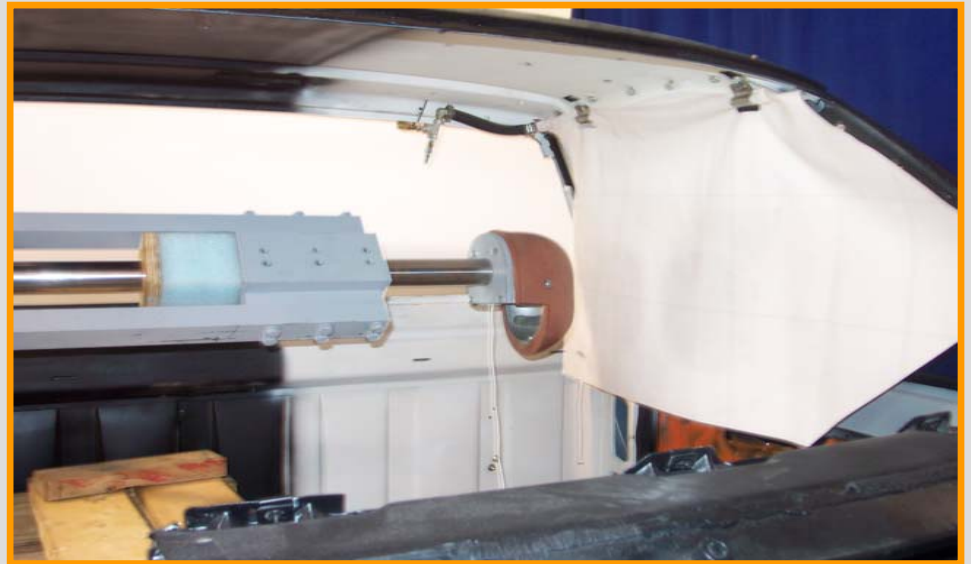
# Ejection Mitigation Guided Impactor

- **18 kg Mass**
- **Featureless Headform**
  - Average of front & side of head geometries
  - More uniform shape
- **Measures Displacement**
- **Positioned Inside Vehicle**
- **Impact a Variety of Locations**

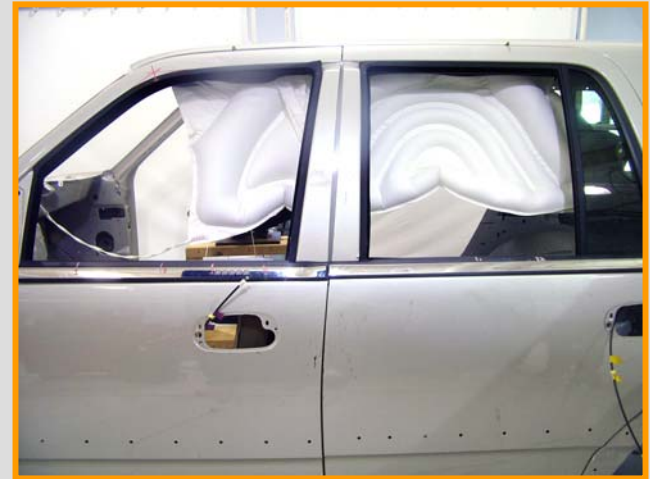
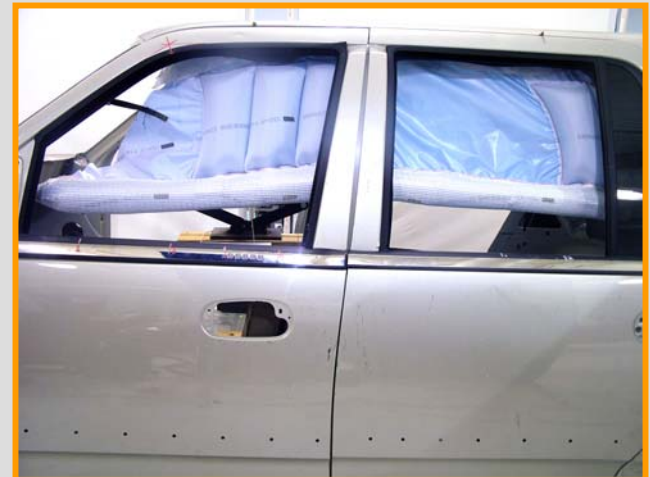
# Ejection Mitigation Systems Evaluated

- **Inflatable Systems**
  - Production Window Curtains
    - 2003 Lincoln Navigator
    - 2004 Volvo XC90
  - Advanced Head Protection Curtain (AHPC)
    - Zodiac Automotive US
- **Inflatable/Laminated Glazing Combination**
  - 2003 Lincoln Navigator (front only)
  - 2004 Volvo XC90

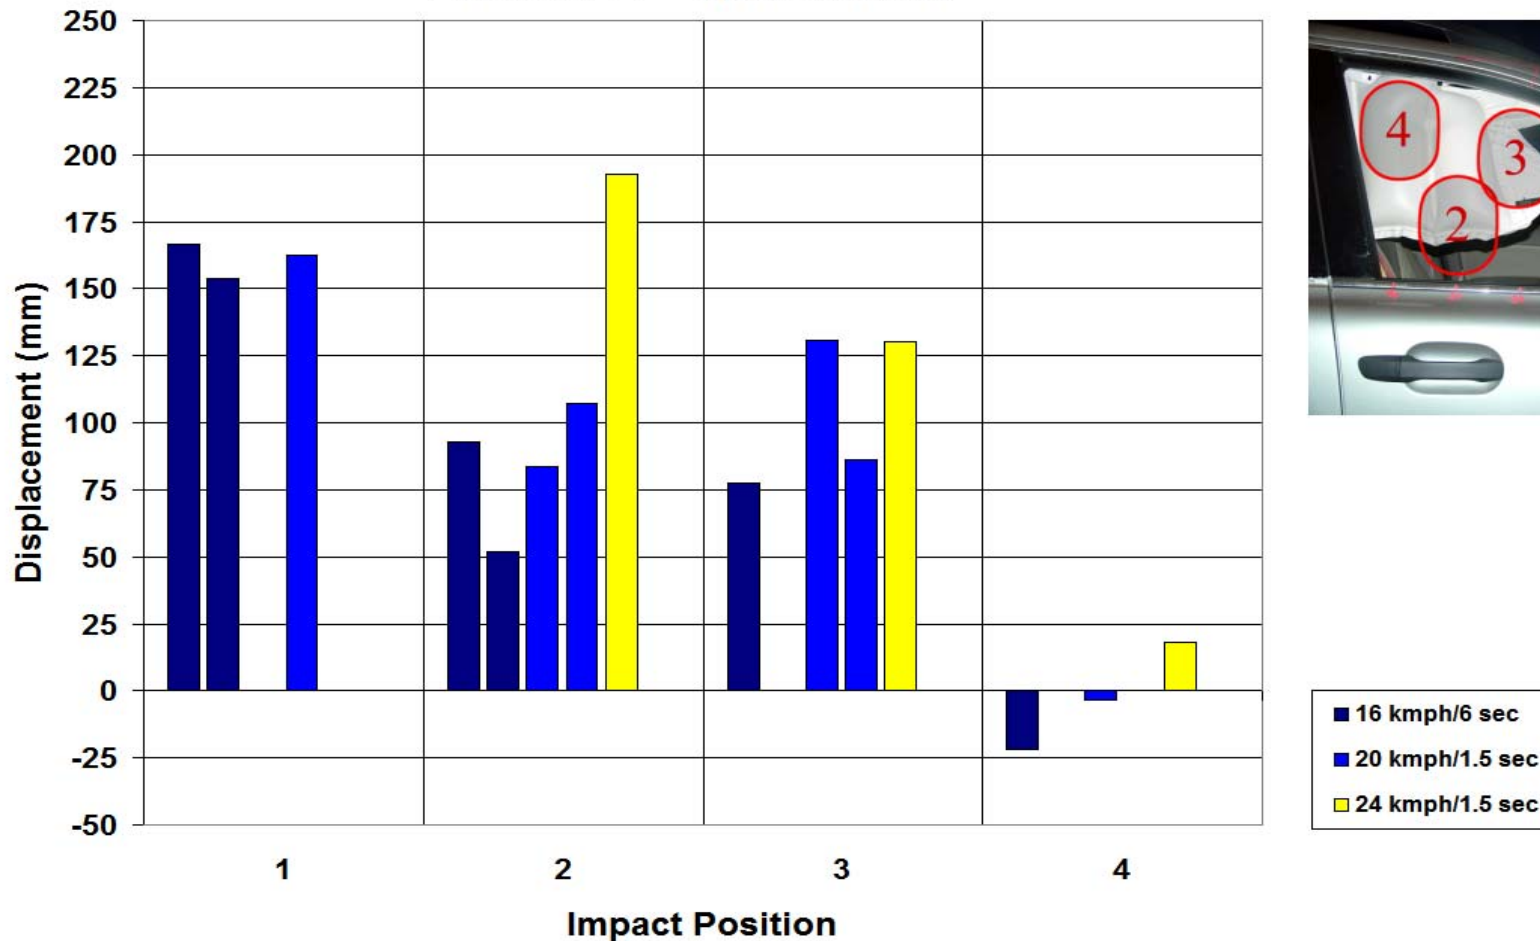
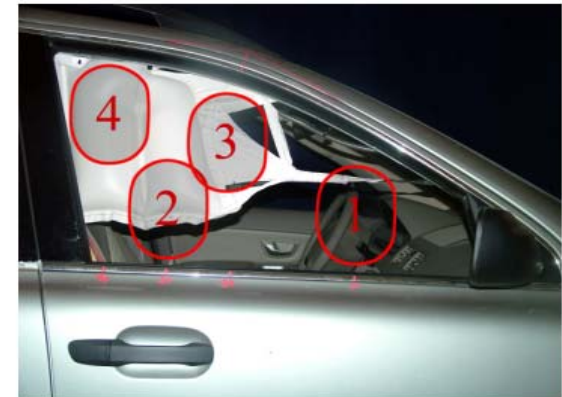
## Impactor Results – Front Window

Maximum Excursion Beyond Window Plane  
Volvo XC90 - Open Window

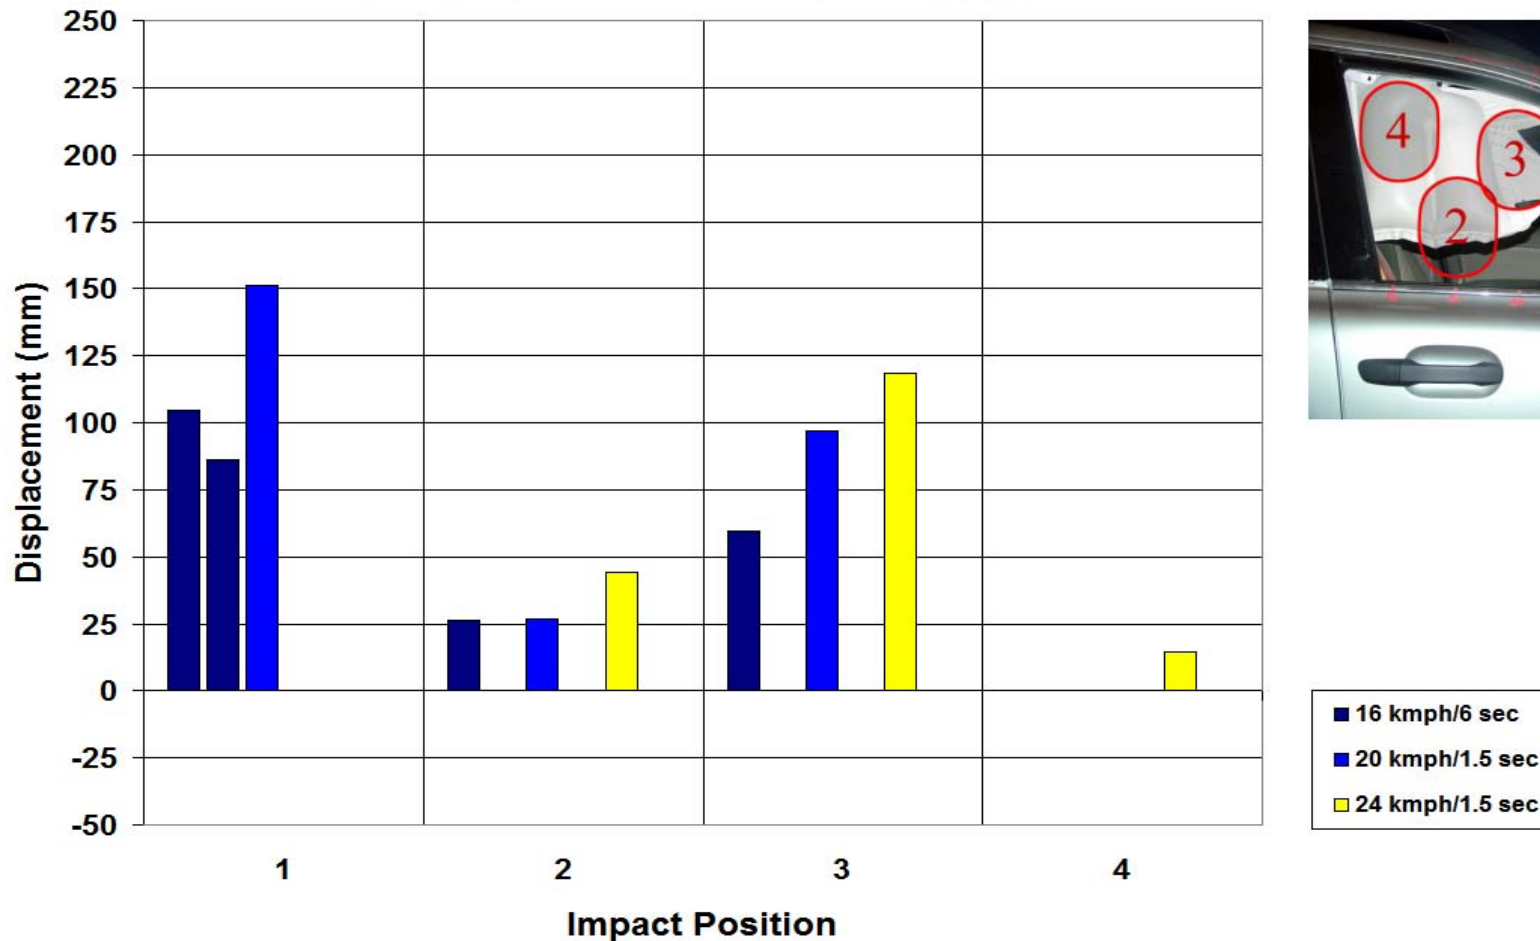
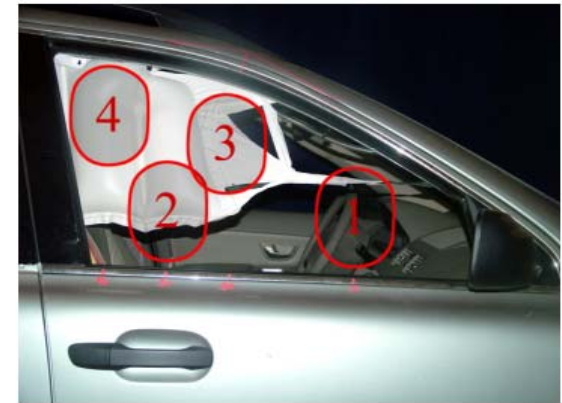
## Impactor Results – Front Window

**Maximum Excursion Beyond Window Plane**  
**Volvo XC90 - Pre-Broken Side Laminates**

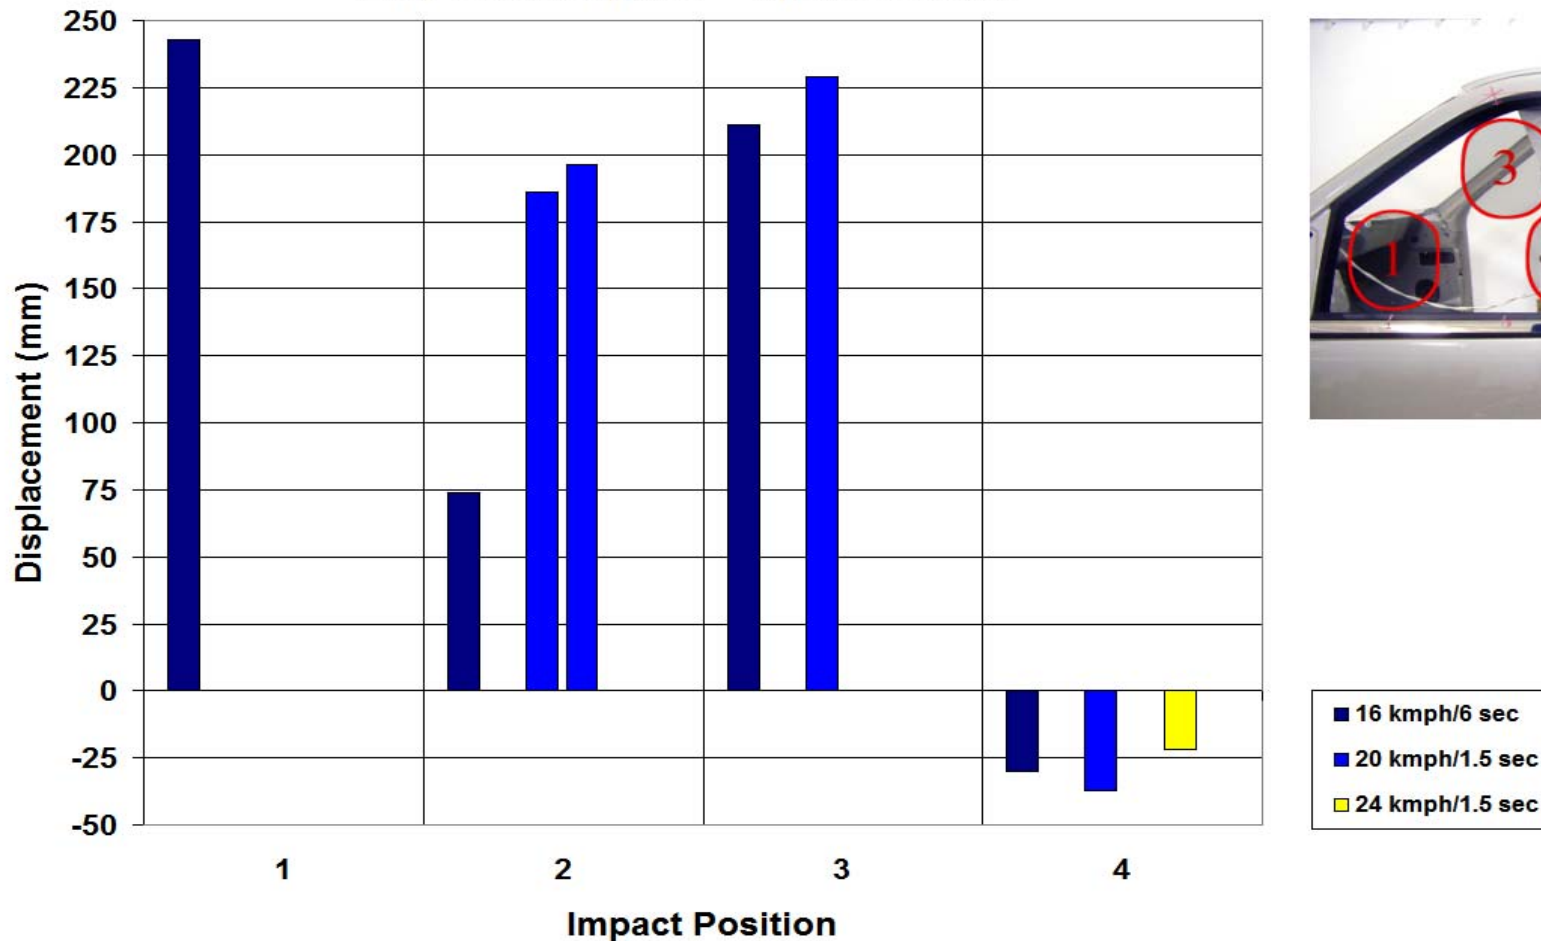
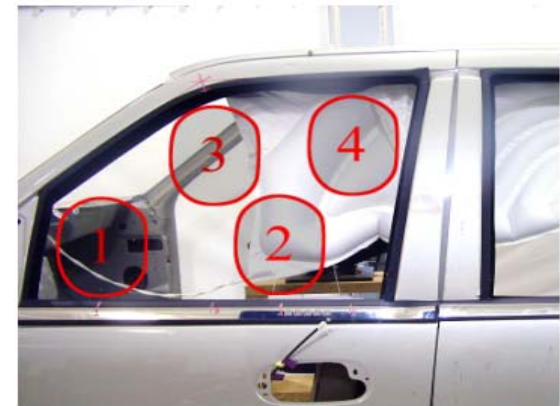
## Impactor Results – Front Window

Maximum Excursion Beyond Window Plane  
Lincoln Navigator - Open Window

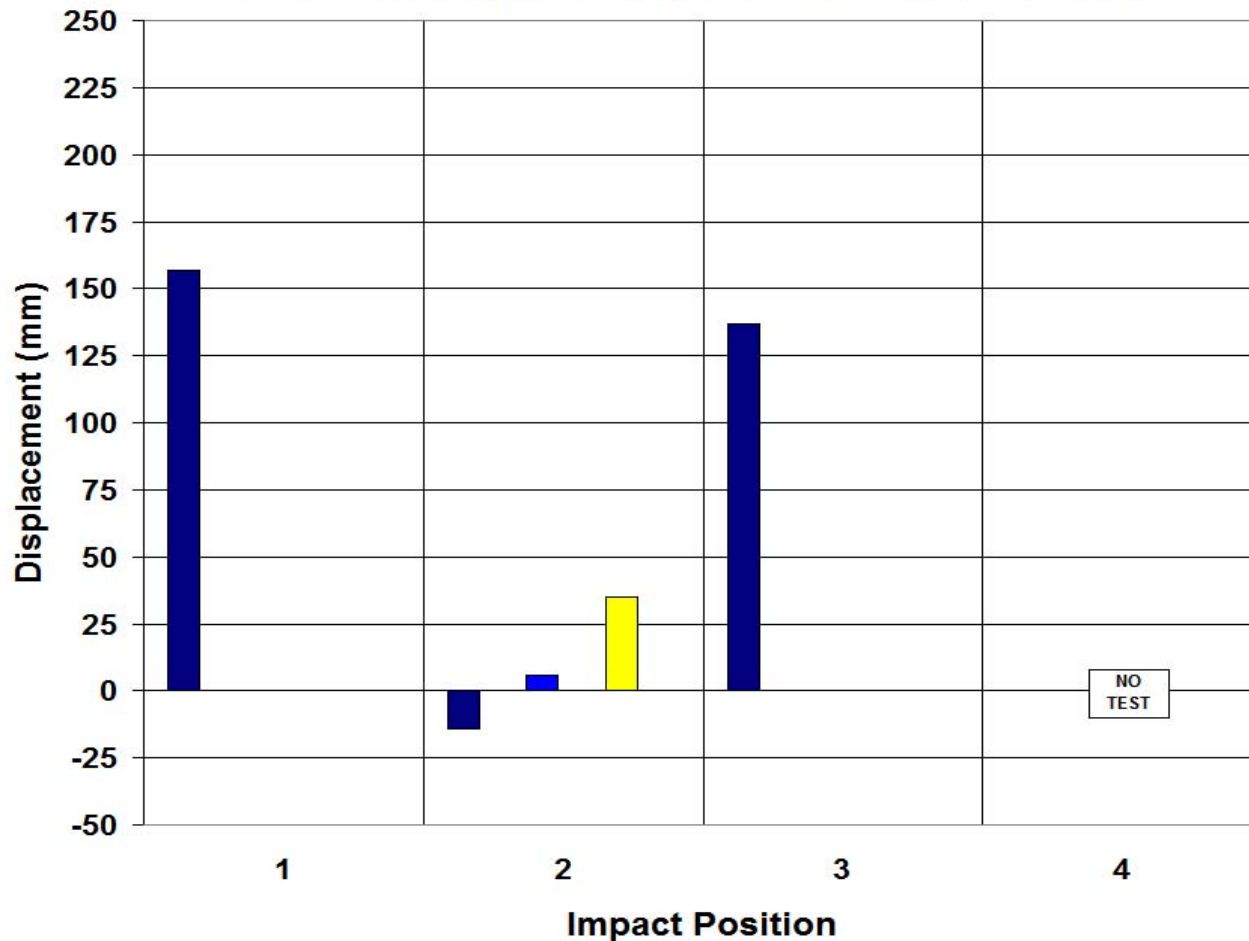
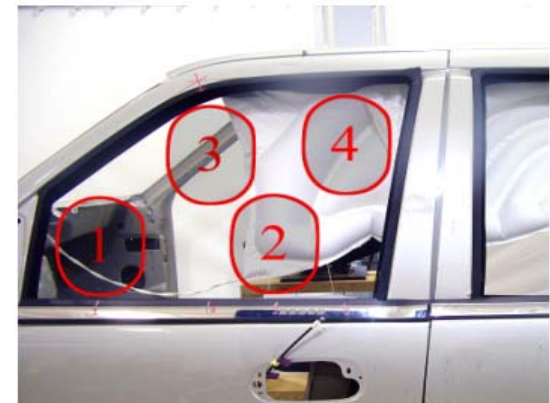
## Impactor Results – Front Window

**Maximum Excursion Beyond Window Plane  
Lincoln Navigator - Pre-Broken Side Laminates**

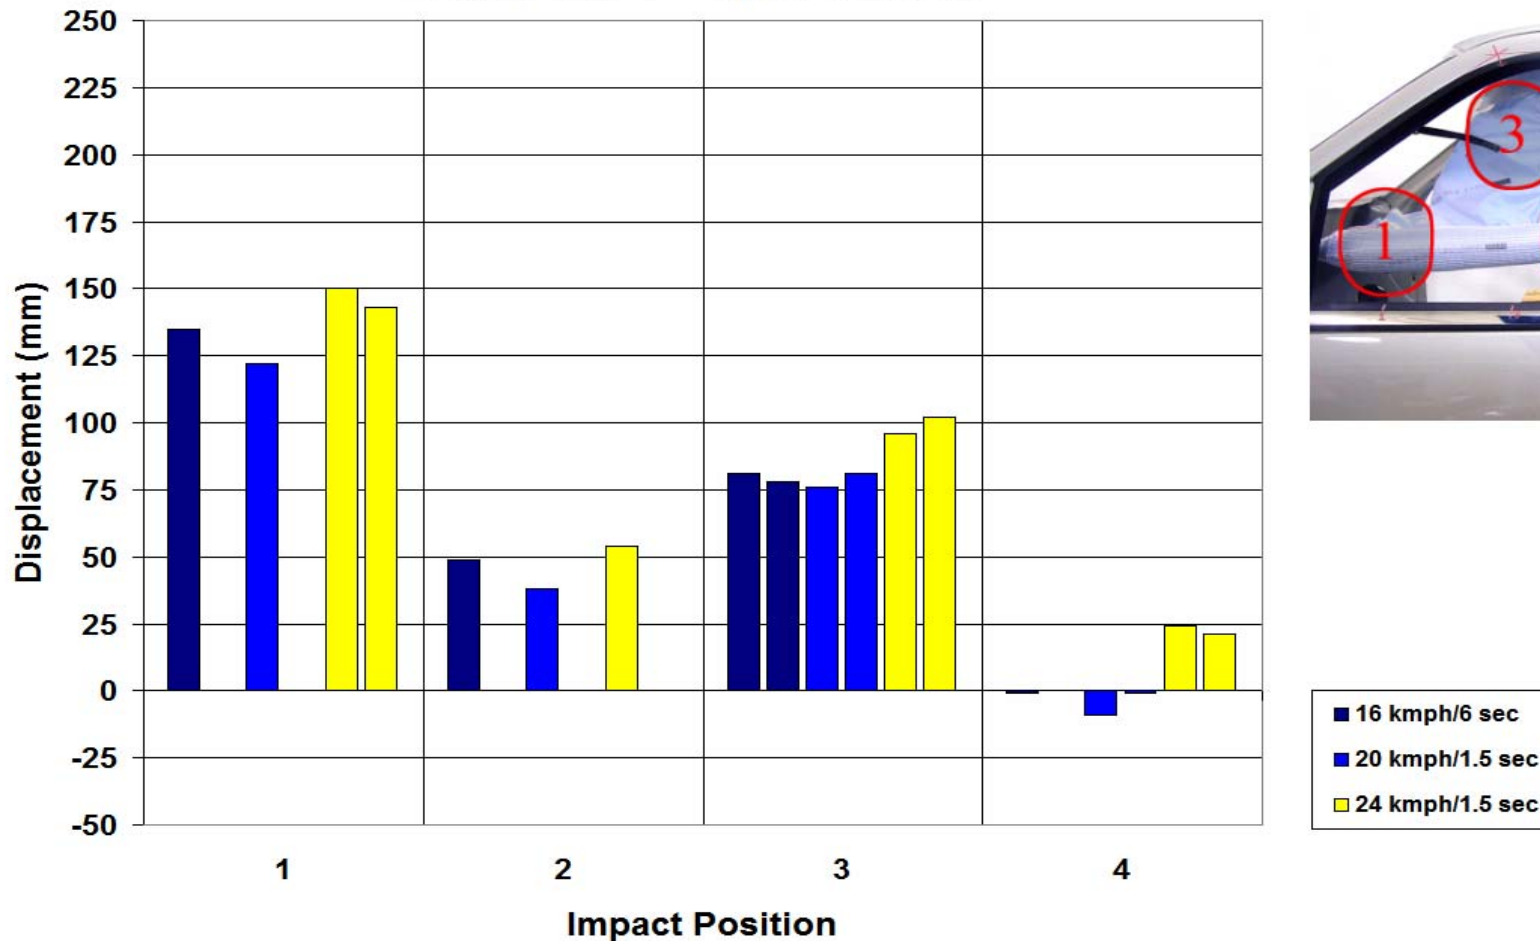
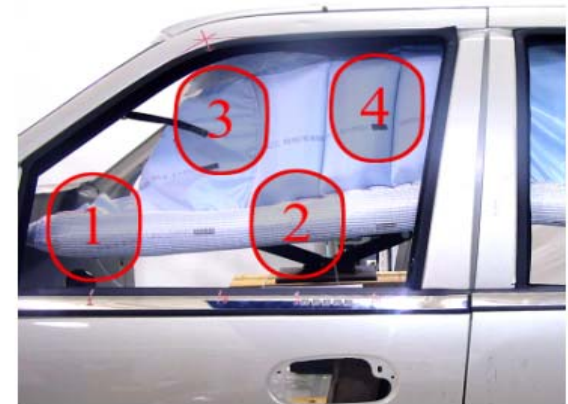
## Impactor Results – Front Window

Maximum Excursion Beyond Window Plane  
Zodiac AHPC - Open Window

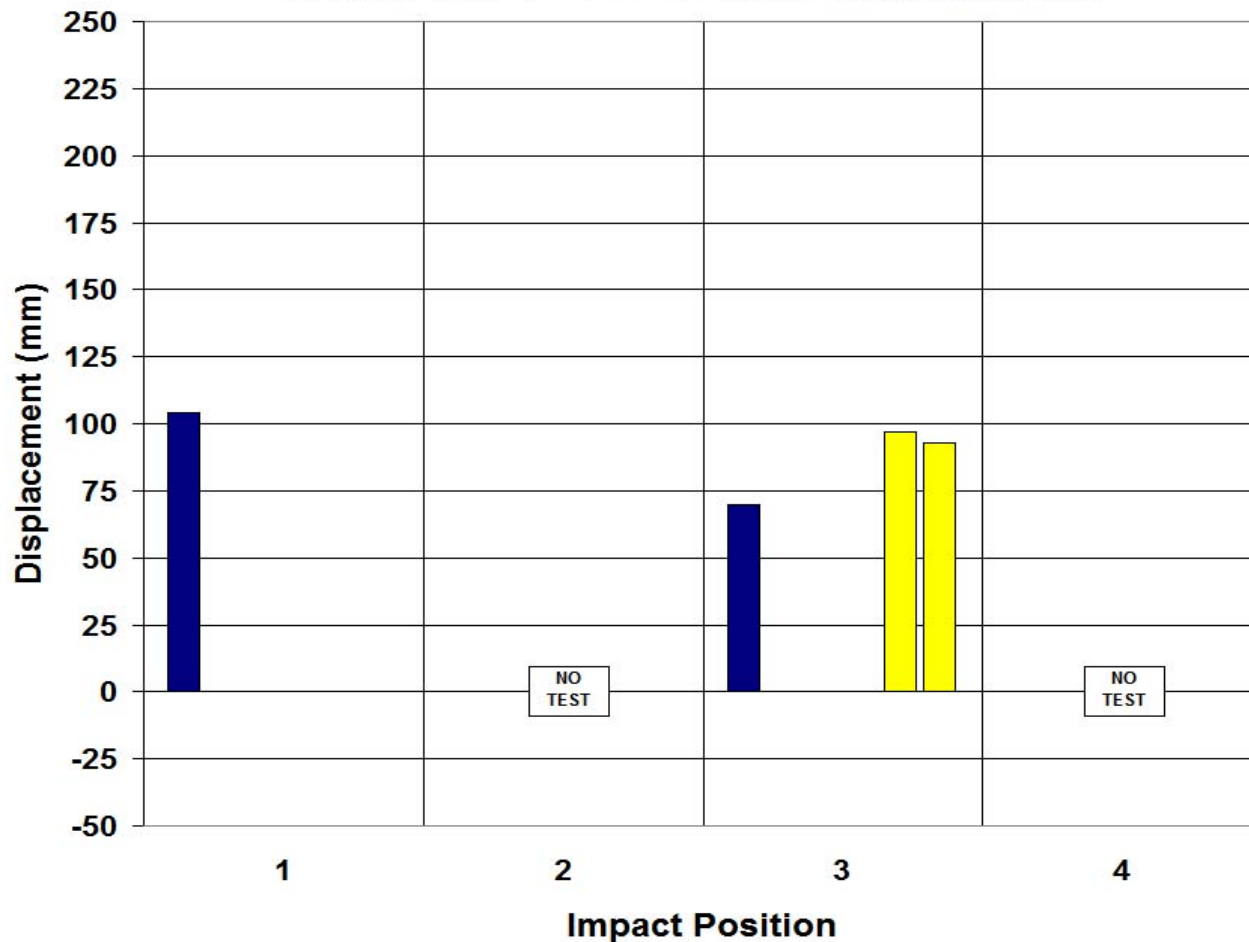
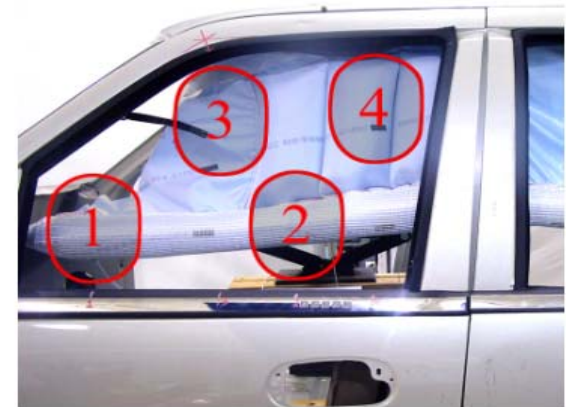
## Impactor Results – Front Window

Maximum Excursion Beyond Window Plane  
Zodiac AHPC - Pre-Broken Side Laminates

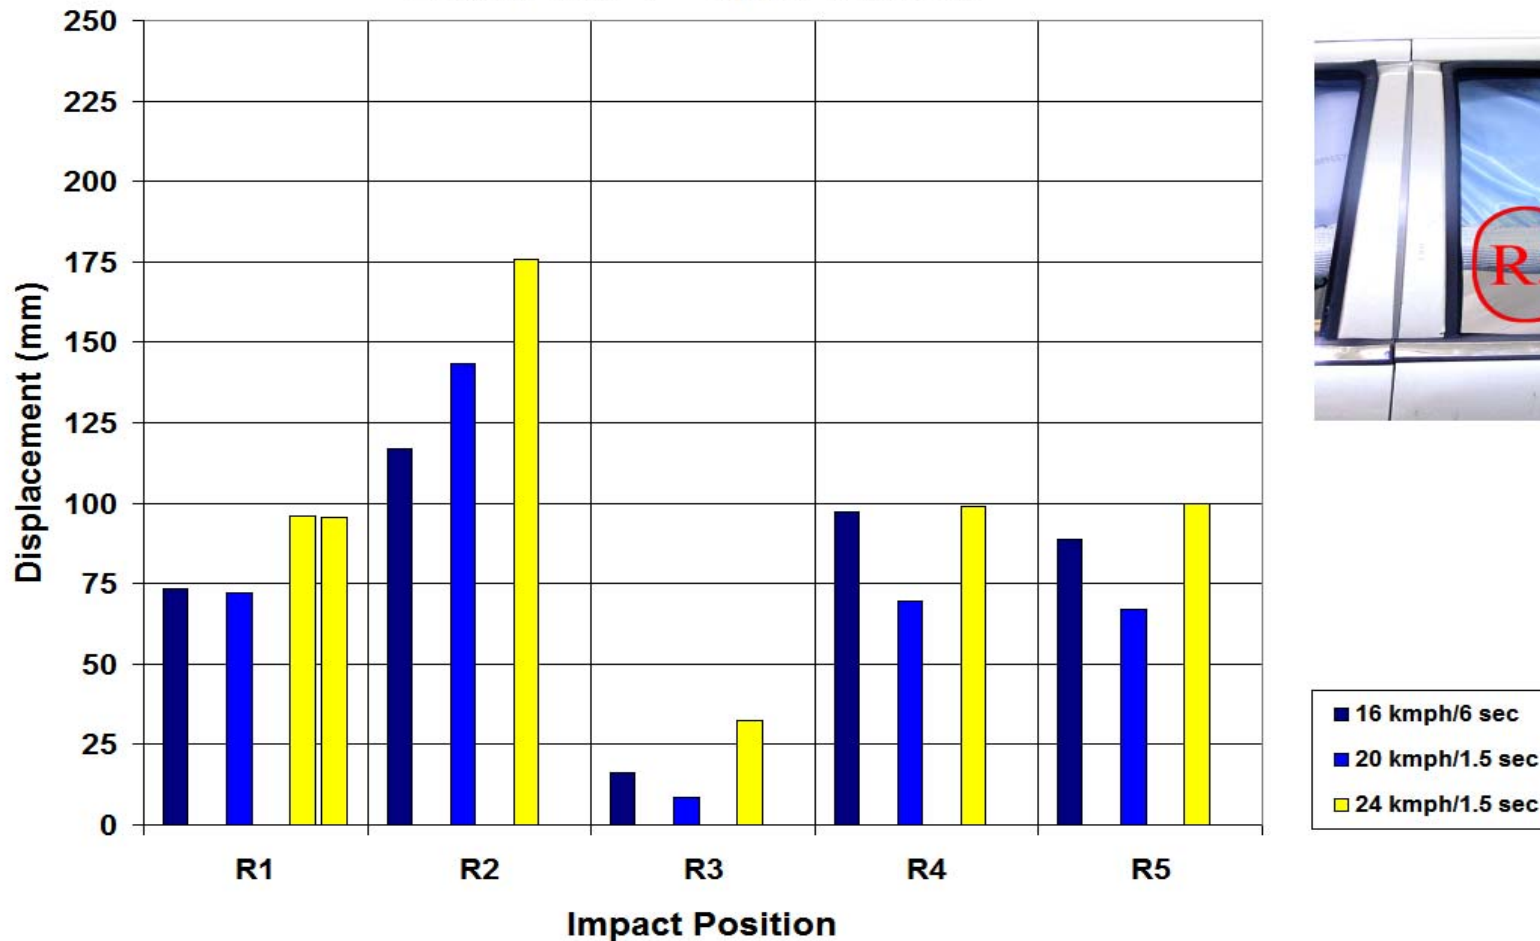
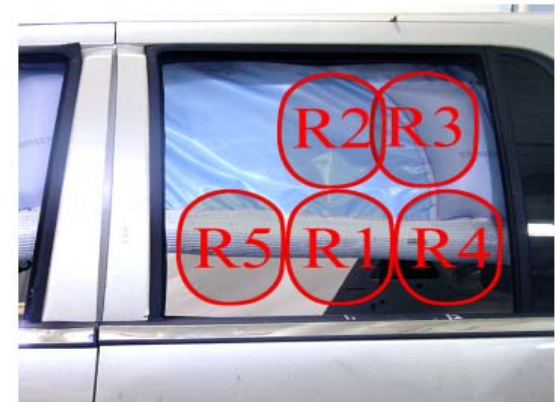
# Ejection Mitigation Impactor Results – Rear Window

Maximum Excursion Beyond Window Plane  
Zodiac AHPC - Open Window

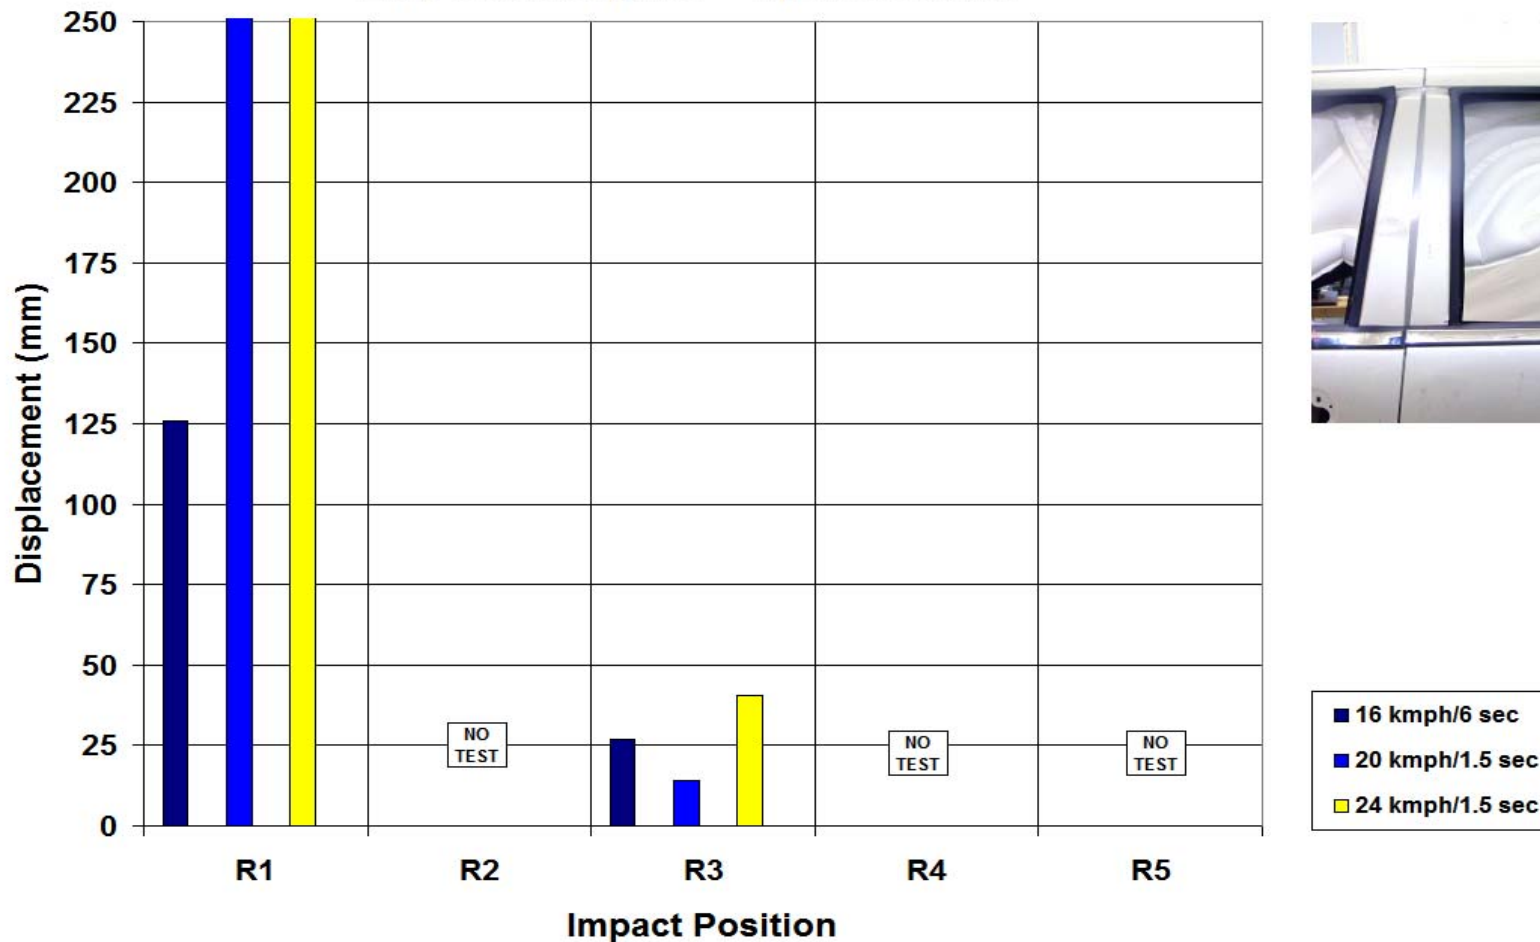
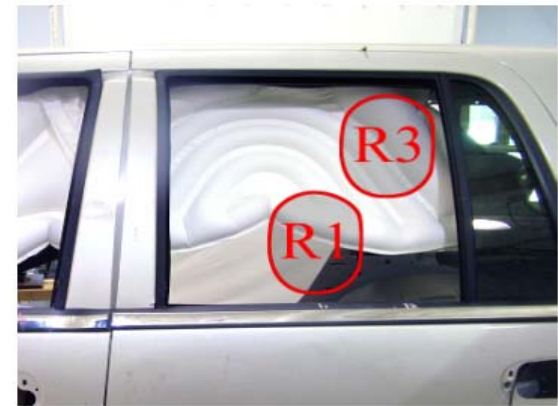
# Ejection Mitigation Impactor Results – Rear Window

Maximum Excursion Beyond Window Plane  
Lincoln Navigator - Open Window

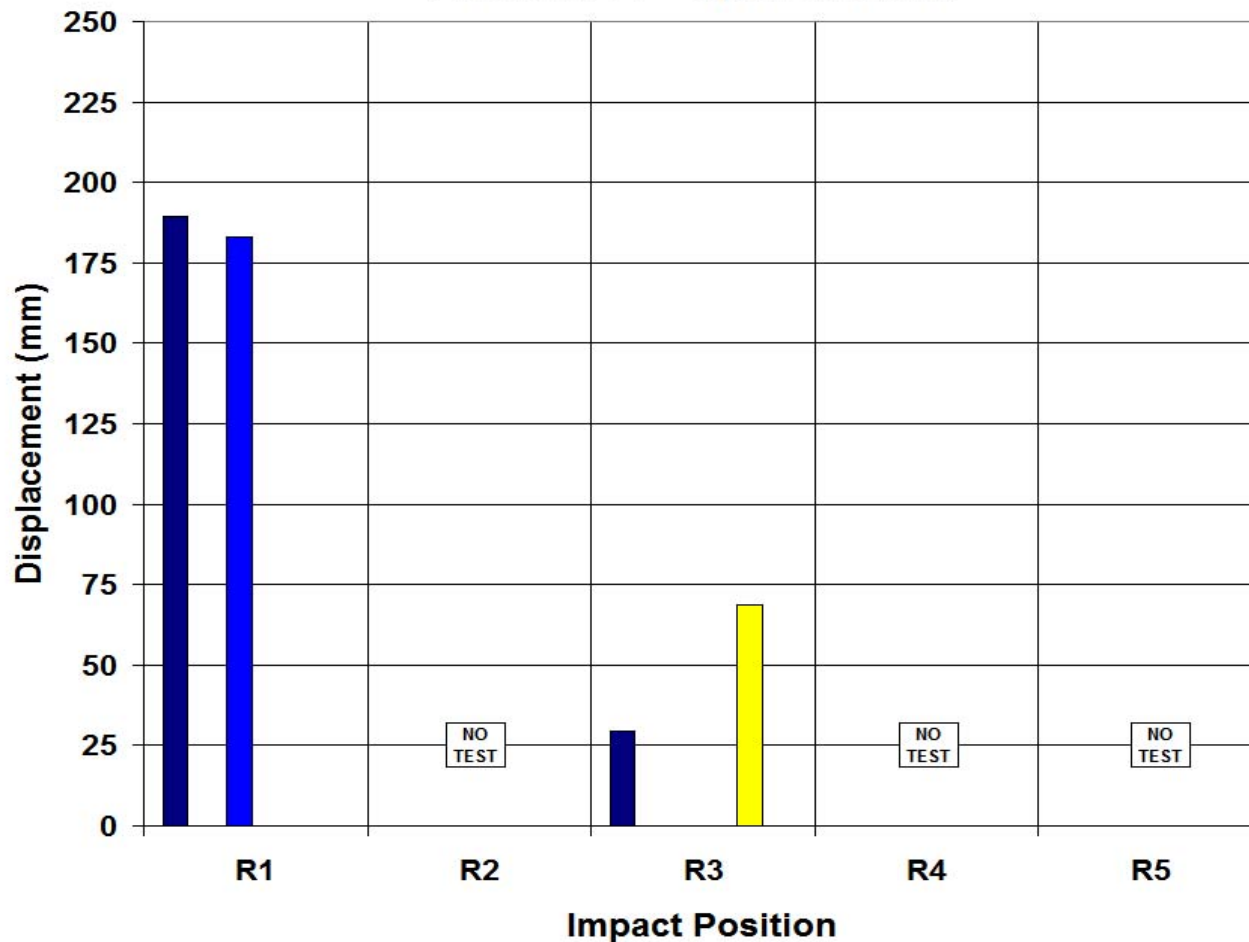
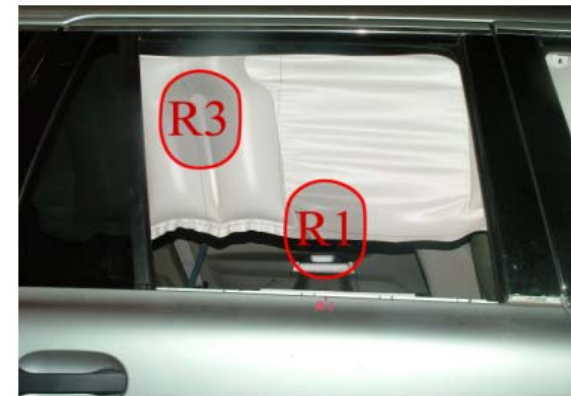
# Ejection Mitigation Impactor Results – Rear Window

Maximum Excursion Beyond Window Plane  
Volvo XC90 - Open Window

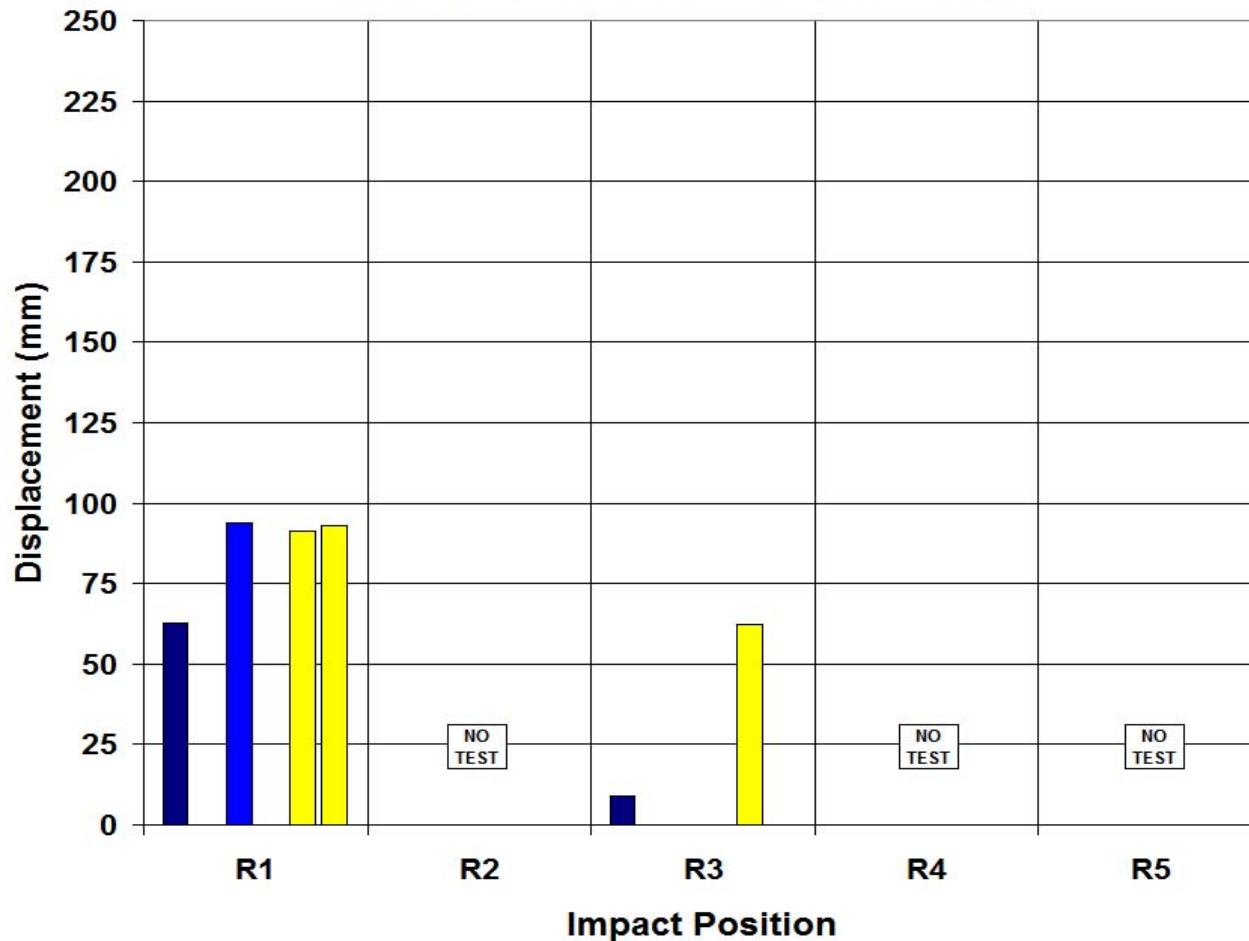
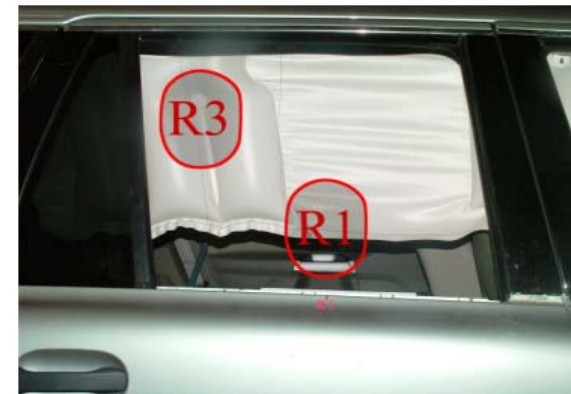
# Ejection Mitigation Impactor Results – Rear Window

**Maximum Excursion Beyond Window Plane  
Volvo XC90 - Pre-Broken Side Laminate**
